ATK STUDY SITE: Tetves, Hungary

LOCATION & LANDUSE

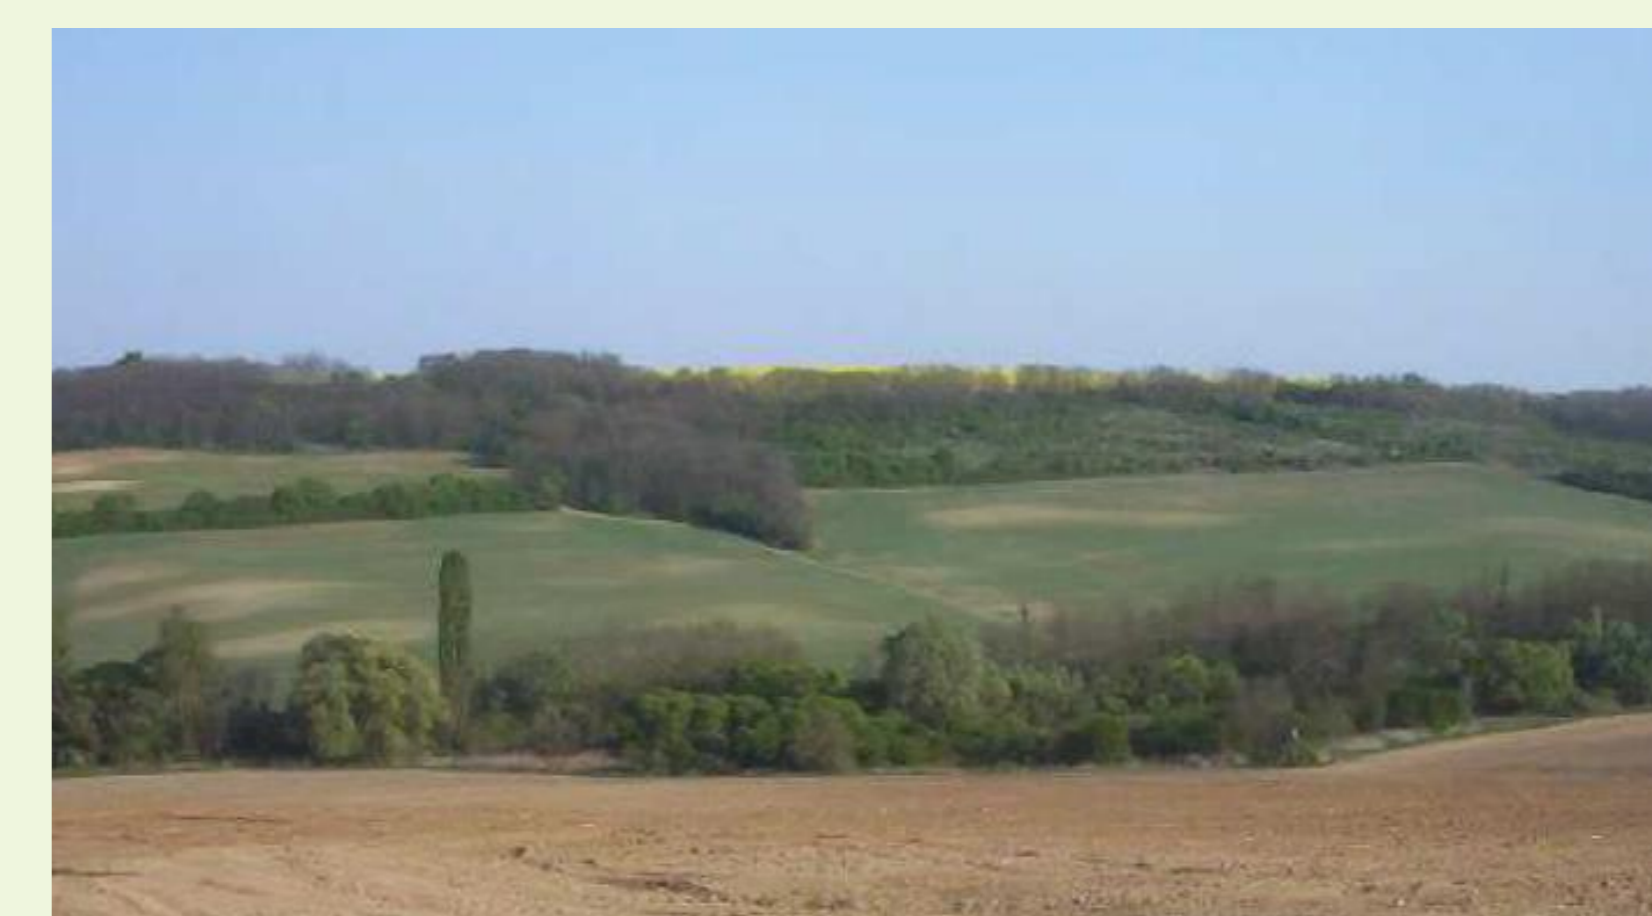
Soil erosion is a significant problem in the catchment, especially the gully erosion.

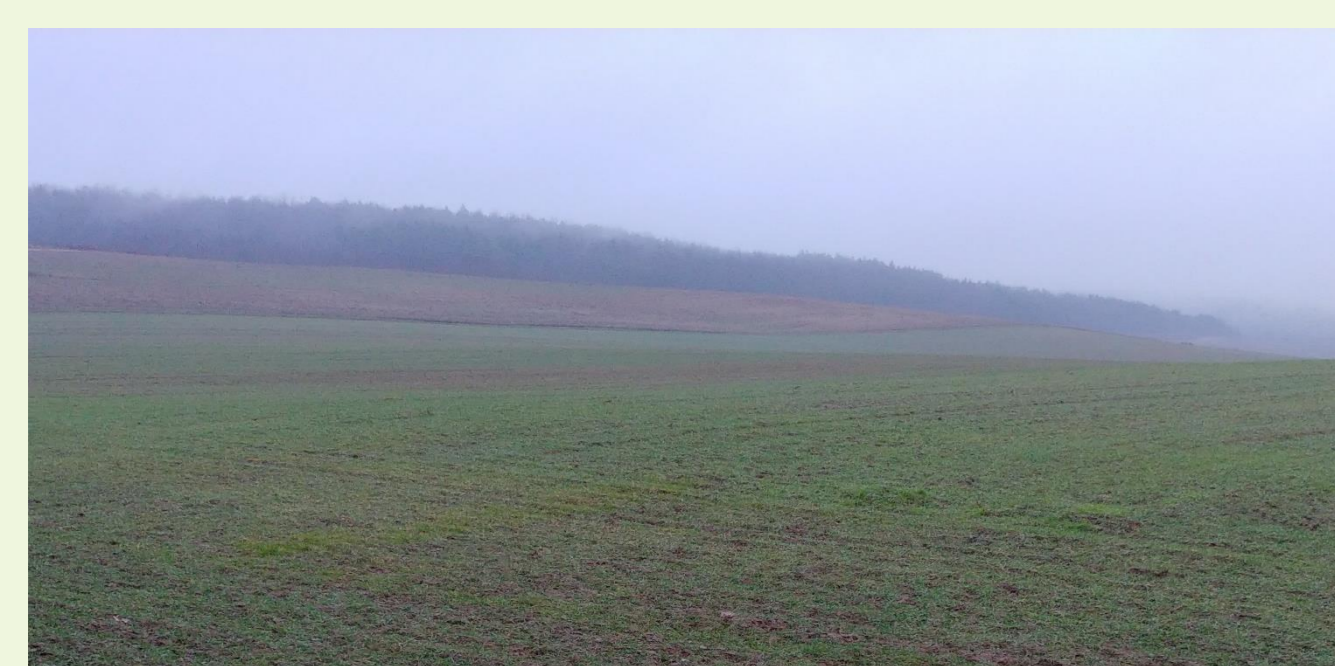
▷ Strip cropping along contours

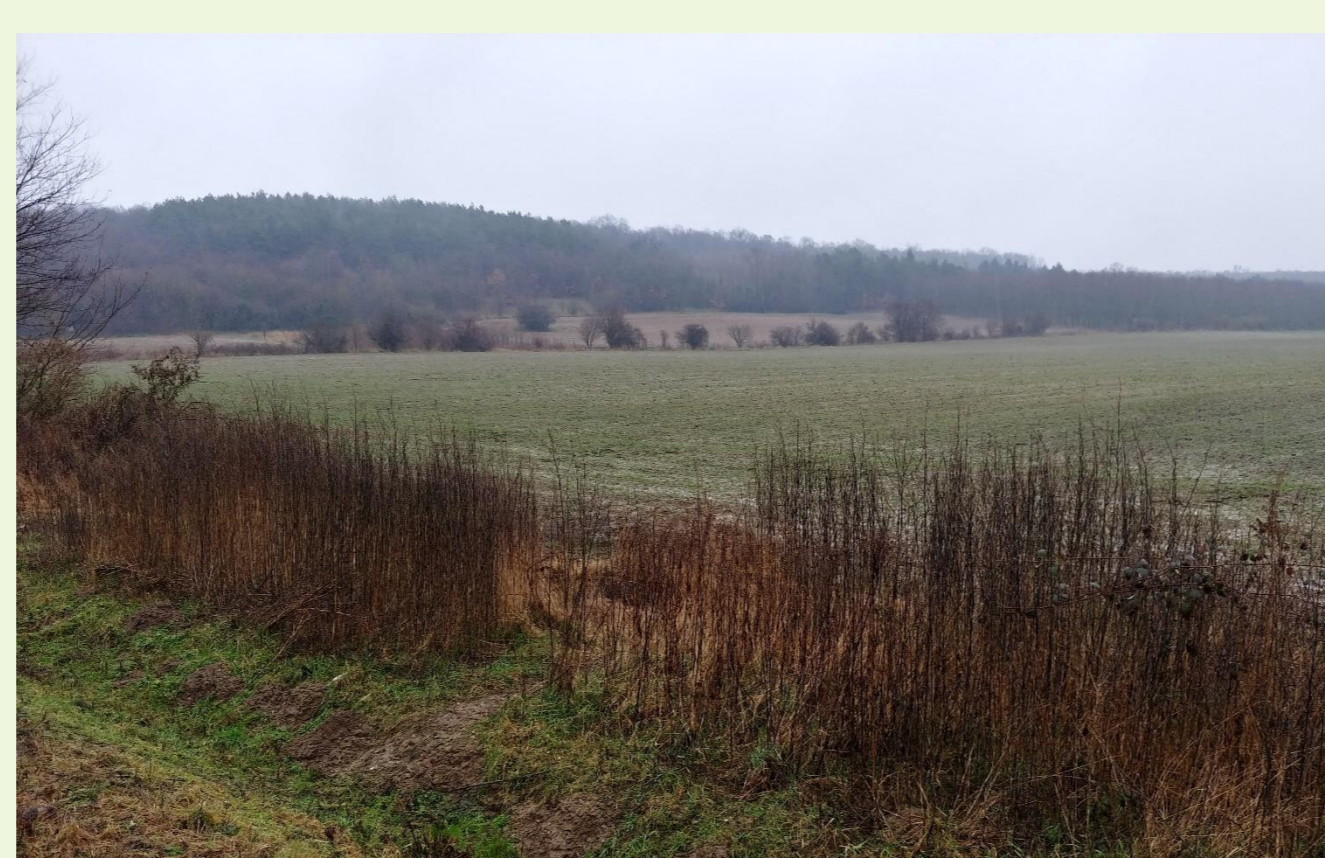
Buffer strips and hedges ◁

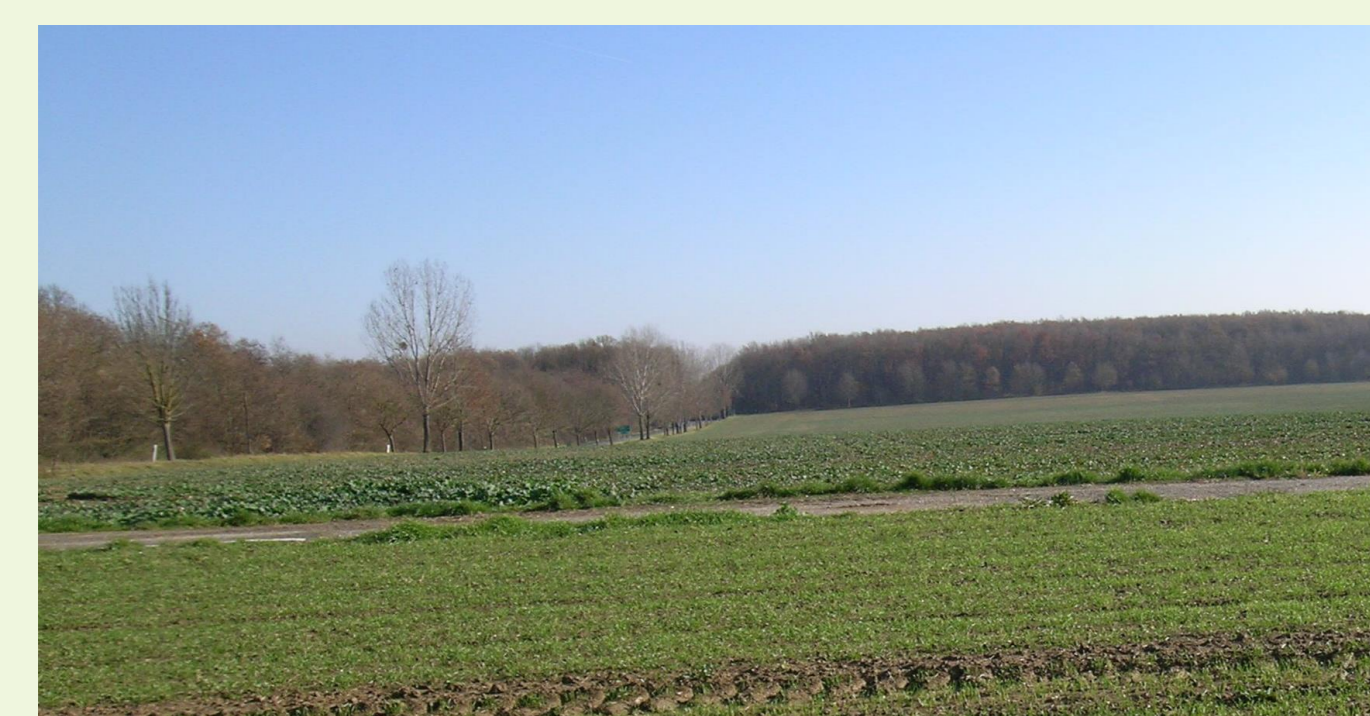
▷ Crop rotation

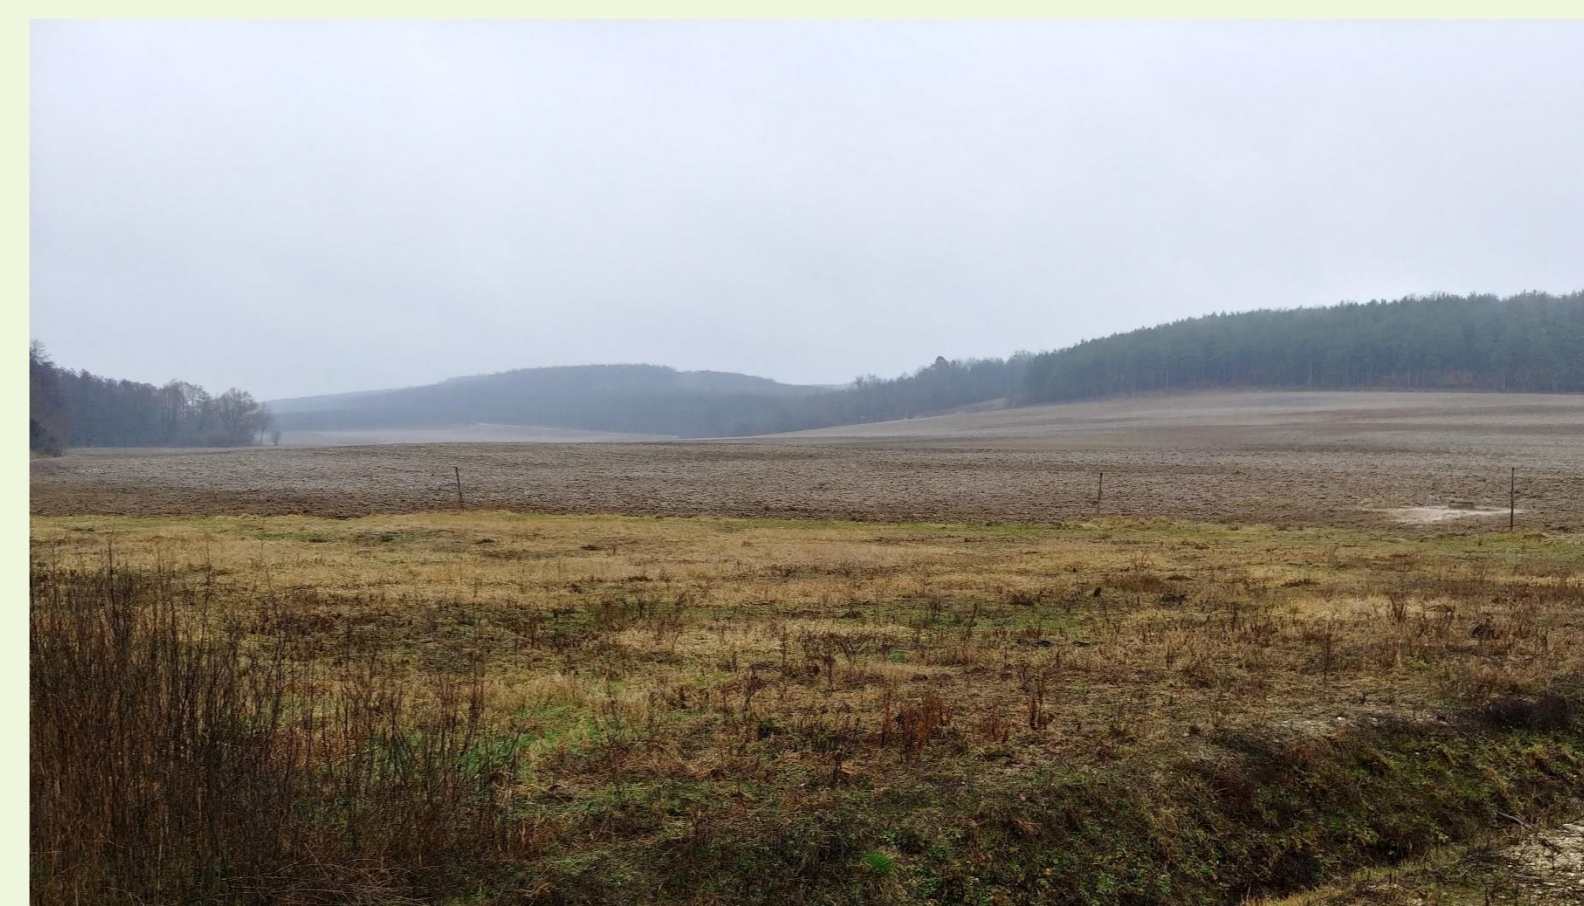
◁ Large temporal variability of precipitation in combination with spatial variability of soil and spatiotemporal variability of land management.

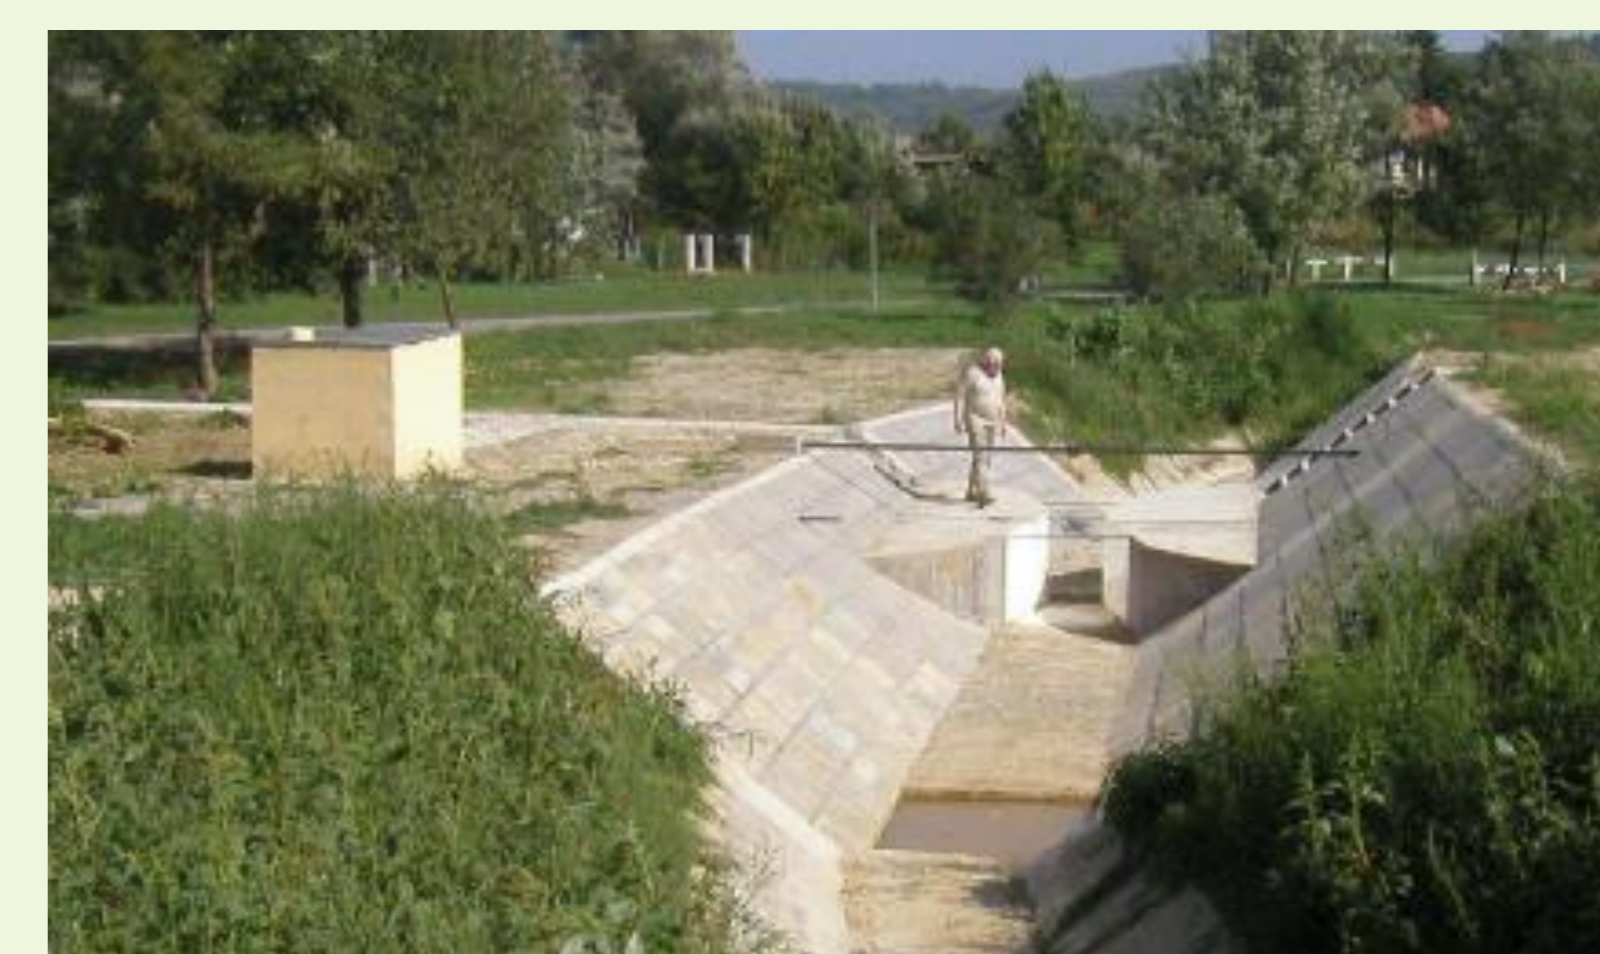
Soil erosion monitoring station ◁
